NAVIGATING THE ROAD TO ZERO STRATEGY

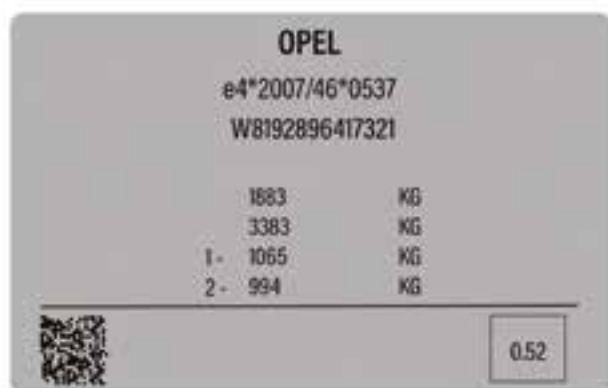
The plate value is the emission limit specified by the vehicle manufacturer, found on the VMs plate. It will be a number (usually in a box) often at the bottom-right corner of the plate. In **Figure 1**, below left – the plate value is 0.52m-1. In **Figure 2**, the plate value is 1.82m-1.
